**MUNICIPALITY OF LEAMINGTON
DRAINAGE FACILITY STUDY
B & C PUMPING STATION**

January 2007
Project No. 161001259.201

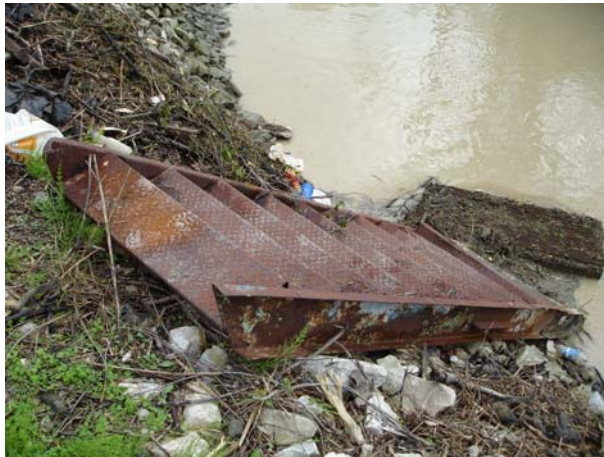
Figure 4-1

The primary pump enclosure is in fair condition. However, the access stairs to the inlet screen are corroded and are not secured. The stairs also do not meet building code requirements as can be seen in Figure 4-1.

It is recommended to replace the access stairs to the inlet screen. The new construction shall include handrails and guarding around the inlet to comply with the building code.

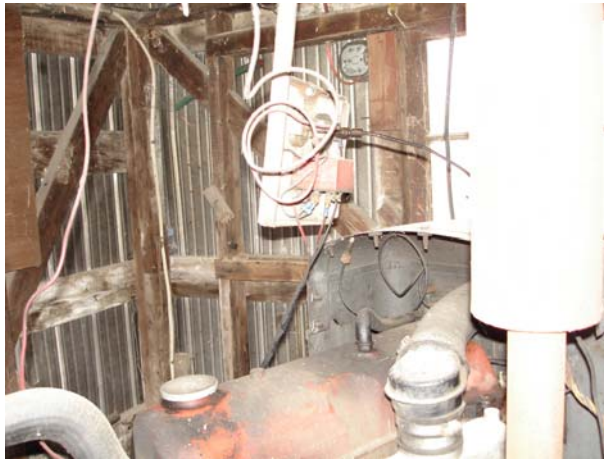
Figure 4-2

The secondary pump building is in need of considerable repair or replacement (see figure 4-2).

Since this building is no longer in use and deemed unsafe due to its dilapidated condition and proximity to residential homes, it is recommended to demolish this building.

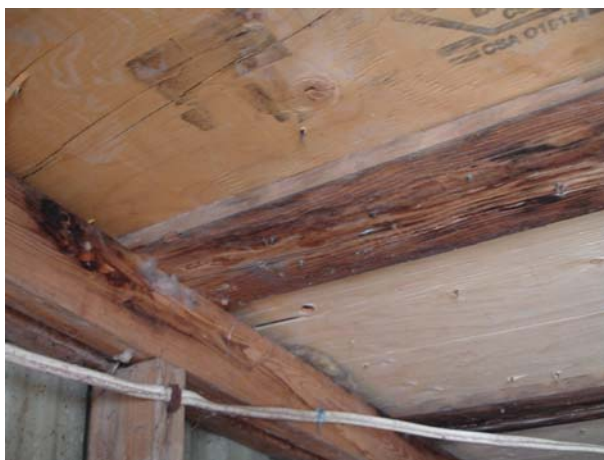
Figure 4-3

Water leaking from the roof onto electrical equipment, which can potentially lead to an electrical hazard as seen in Figure 4.3.

Replace roof material with new to prevent any further moisture entering the building.

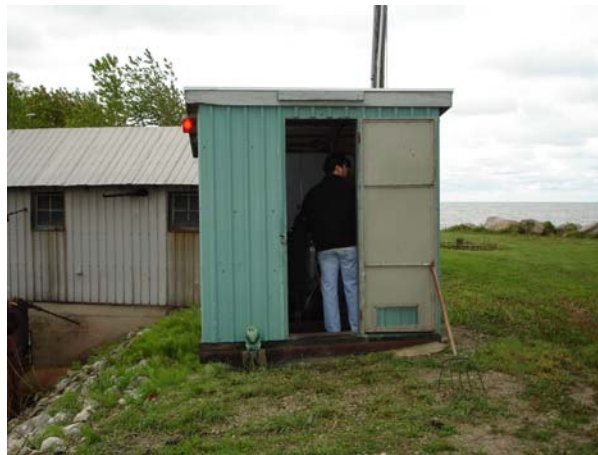
Figure 4-4

The entrance door of the building has an opening at the bottom of the door used for ventilation which allows for the entrance unwanted animals and debris as seen in Figure 4-4.

It is recommended that this opening be covered by a metal grille and a bird screen to prevent any animals or unwanted debris from entering into the building.

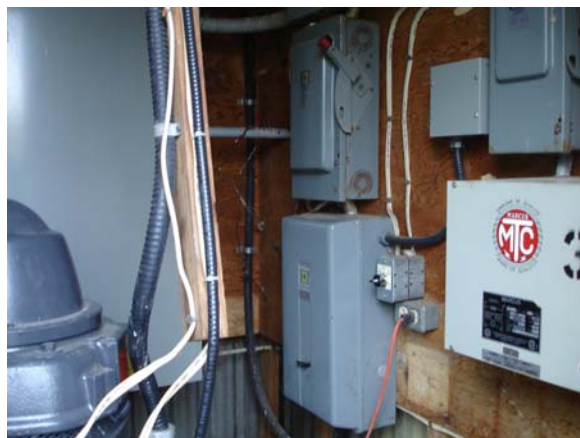
Figure 4-5

The electrical distribution equipment housed in the building for the electric driven pump does not have the proper 1 meter un-obstructive clearance as required by the Electrical code as can be seen in Figure 4-5. Upon review of the documents received by the Municipality with respect to this pump station, there was no indication of an electrical certificate of final inspection to indicate that it has passed the electrical safety inspection conducted by Electrical Safety Authority (ESA). If there was an electrical certificate of final inspection, this might indicate any variances that could have been given to supercede this code requirement.

Since there is no indication of any variances to the 1 meter clearance in front of electrical equipment, it is recommended that the electrical distribution equipment be housed in a corrosion resistance weatherproof enclosure and mounted outdoors on the exterior wall of the building.

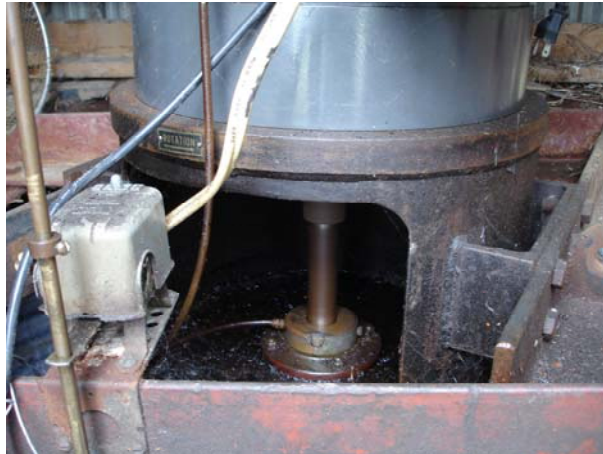
The electrical wiring within the electric pump building does not have adequate mechanical protection to prevent the wire insulation from being compromised, which may lead to the potential of being exposed to live conductors. Refer to Figure 4-6 as one of many examples.

Replace existing NMS (non metallic sheathed) type wiring with T90 conductors in conduit or armoured cable, such as BX or TECK construction.

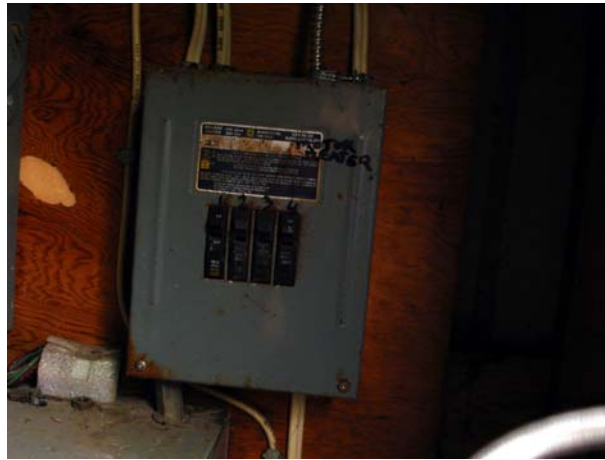
Figure 4-7

Existing four (4) circuit load centre is rusted due to the water leaks. The rusted out load centre can be seen in Figure 4-7.

It is recommended to replace existing four (4) circuit load centre with new since it may not be reliable due to water damage.

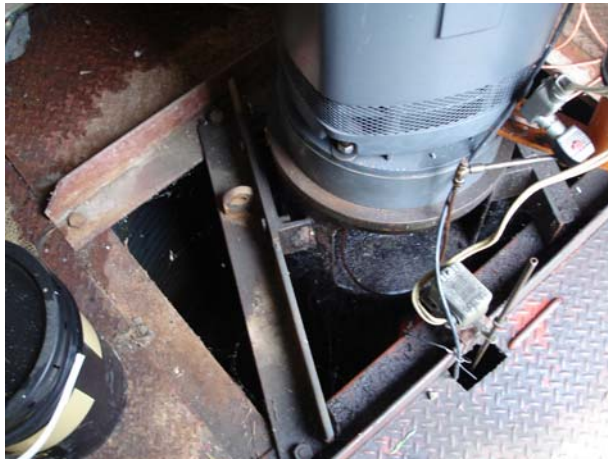
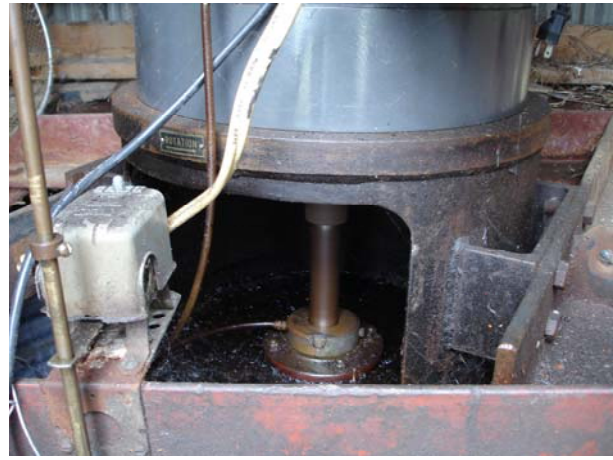
Trip / Slip & Fall hazard exist from holes in floor around electric motor. See Figures 4-8 and 4.9 below.

Fabricate a metal guard around the pump base opening to eliminate the trip hazard.

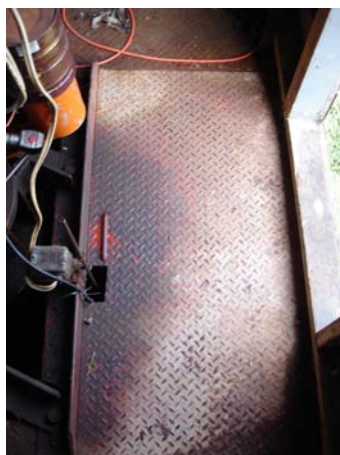
Figure 4-10

Hatch in floor not suitably secured as can be seen in Figure 4-10.

Provide removable fasteners to secure the pump well access hatch to the floor.

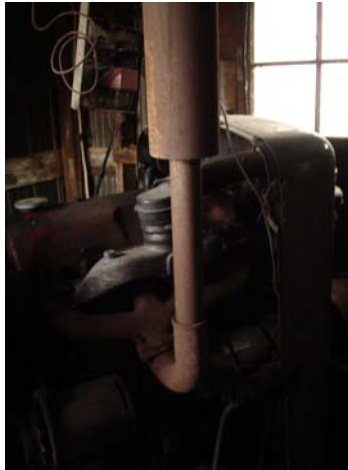
Figure 4-11

Burn hazard on diesel engine exhaust as can be seen in Figure 4-11.

Suitably insulate diesel exhaust stack and muffler to prevent burn hazard. However, we recommend giving this deficiency no further consideration since the diesel driven pump is no longer in use.

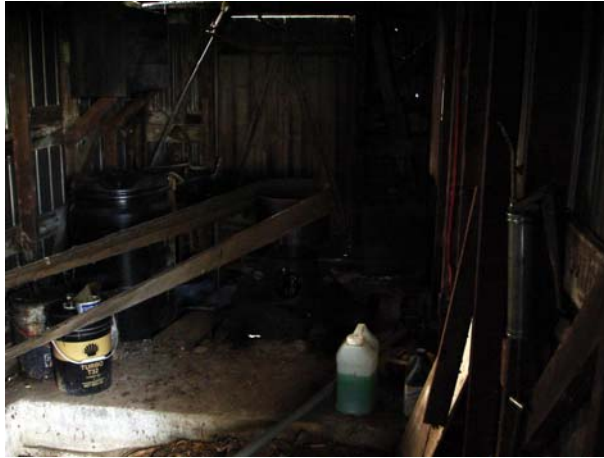
Figure 4-12

Nip point with diesel engine drive belt and associate pulley as can be seen in Figure 4-12.

Proper guarding around drive belt and associated pulley in compliance with OHSA regulations is required. However, we recommend giving this deficiency no further consideration since the diesel driven pump is no longer in use.

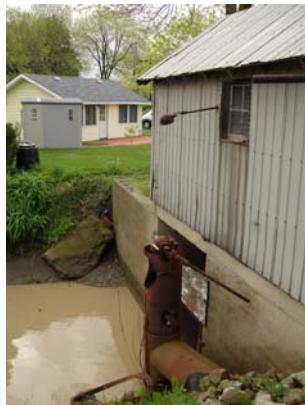
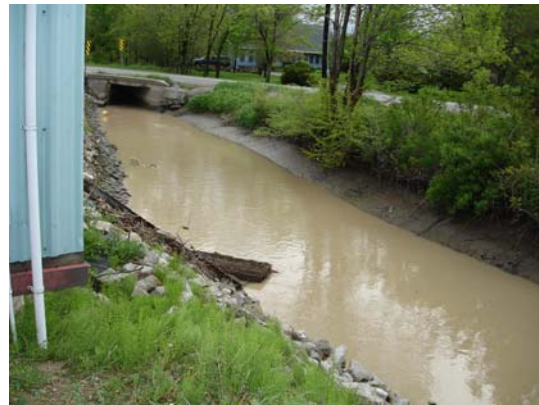
Guardrail was lacking for the fall hazard into water. Refer to Figures 4-13 & 4-14 for examples.

Install suitable guardrail and where a worker is exposed to the hazard of falling into liquid that is of sufficient depth for a life jacket to be effective as protection from the risk of drowning, there shall be an alarm system and rescue equipment, appropriate in the circumstances, to ensure the worker's rescue from the liquid and,

- (a) the worker shall wear a life jacket; or

- (b) the employer shall develop written measures and procedures to prevent the worker from drowning and shall implement them.
