Municipality of
Leamington
live | play | work

Municipal Sewage Collection System 033-W601 2025 Annual Report

Submitted to:
Ontario Ministry of the Environment, Conservation and Parks
March 2026

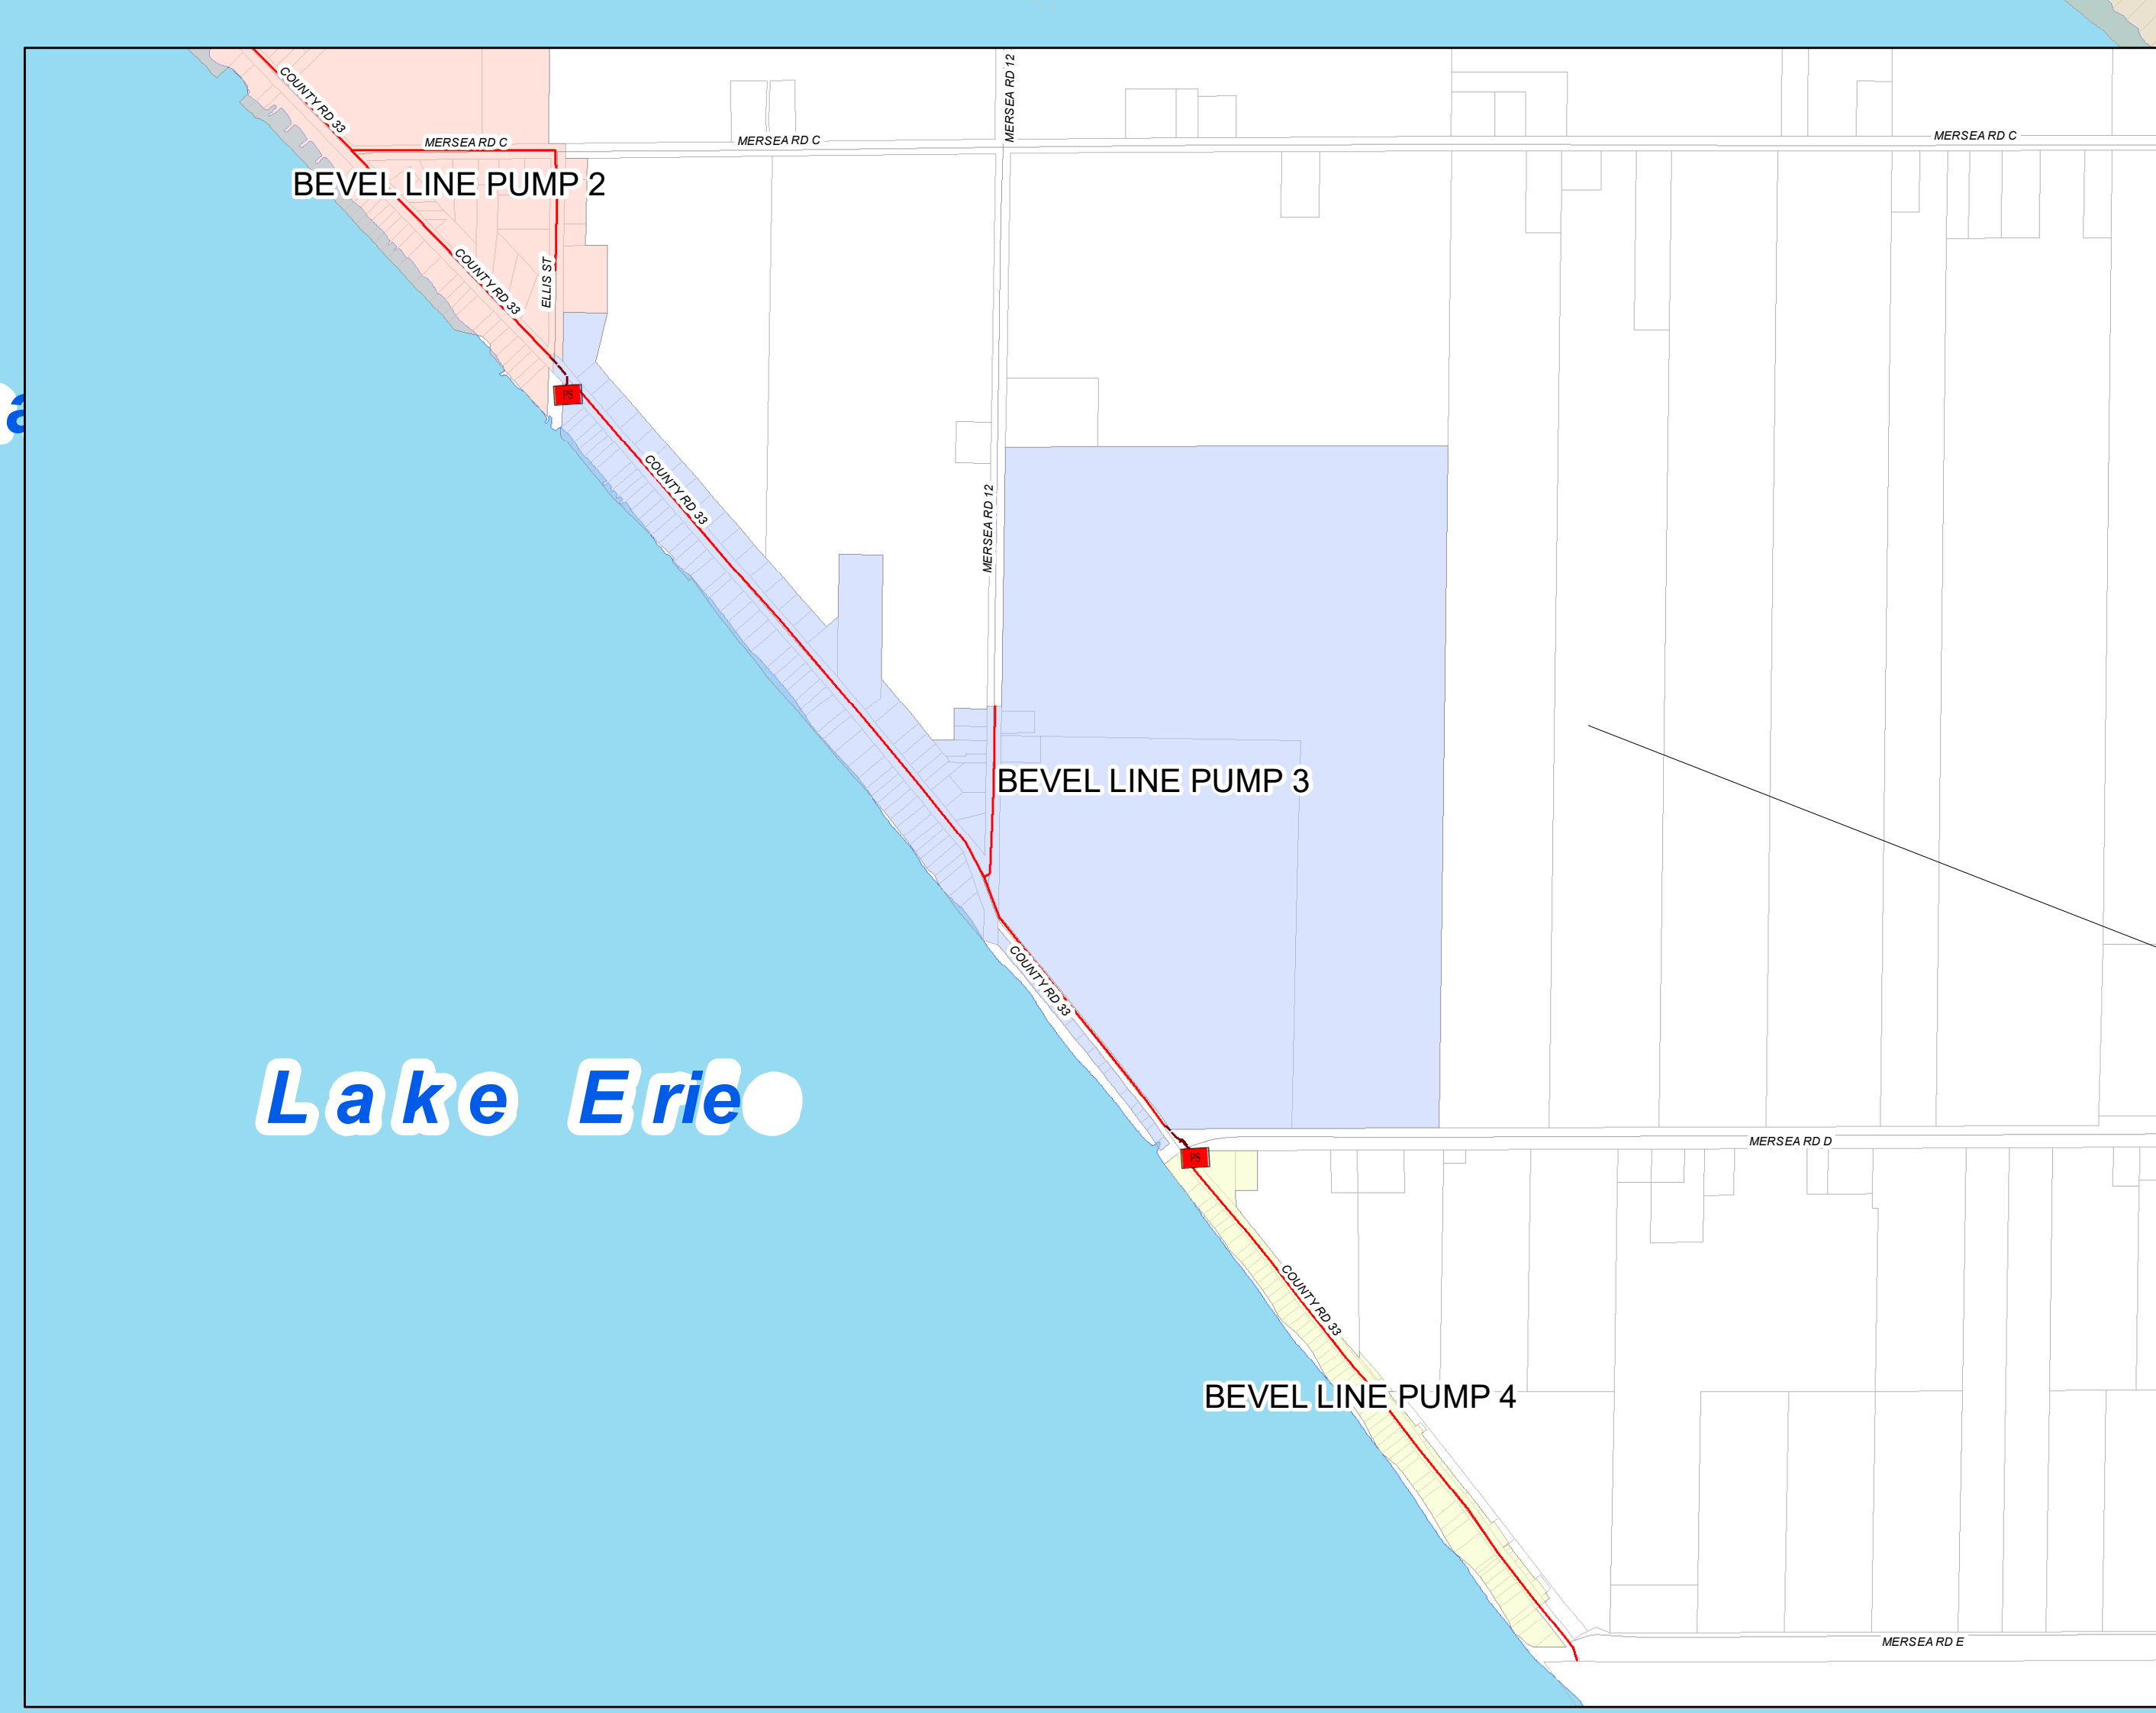
TITLE: MUNICIPALITY OF LEAMINGTON - 2025 SEWER MAP

- ANFRED PUMP
- BEVEL LINE PUMP 1
- BEVEL LINE PUMP 2
- BEVEL LINE PUMP 3
- BEVEL LINE PUMP 4
- CHERRY LANE
- PCC DIRECT
- ERIE GLEN PUMP
- ERIE SHORES
- ERIE SOUTH PUMP
- MALIBU PUMP
- PETER
- PICKWICK
- SANDY LAKES PUMP
- SEACLIFF PARK
- SELKIRK
- WILLOUSA PUMP
- Parcels

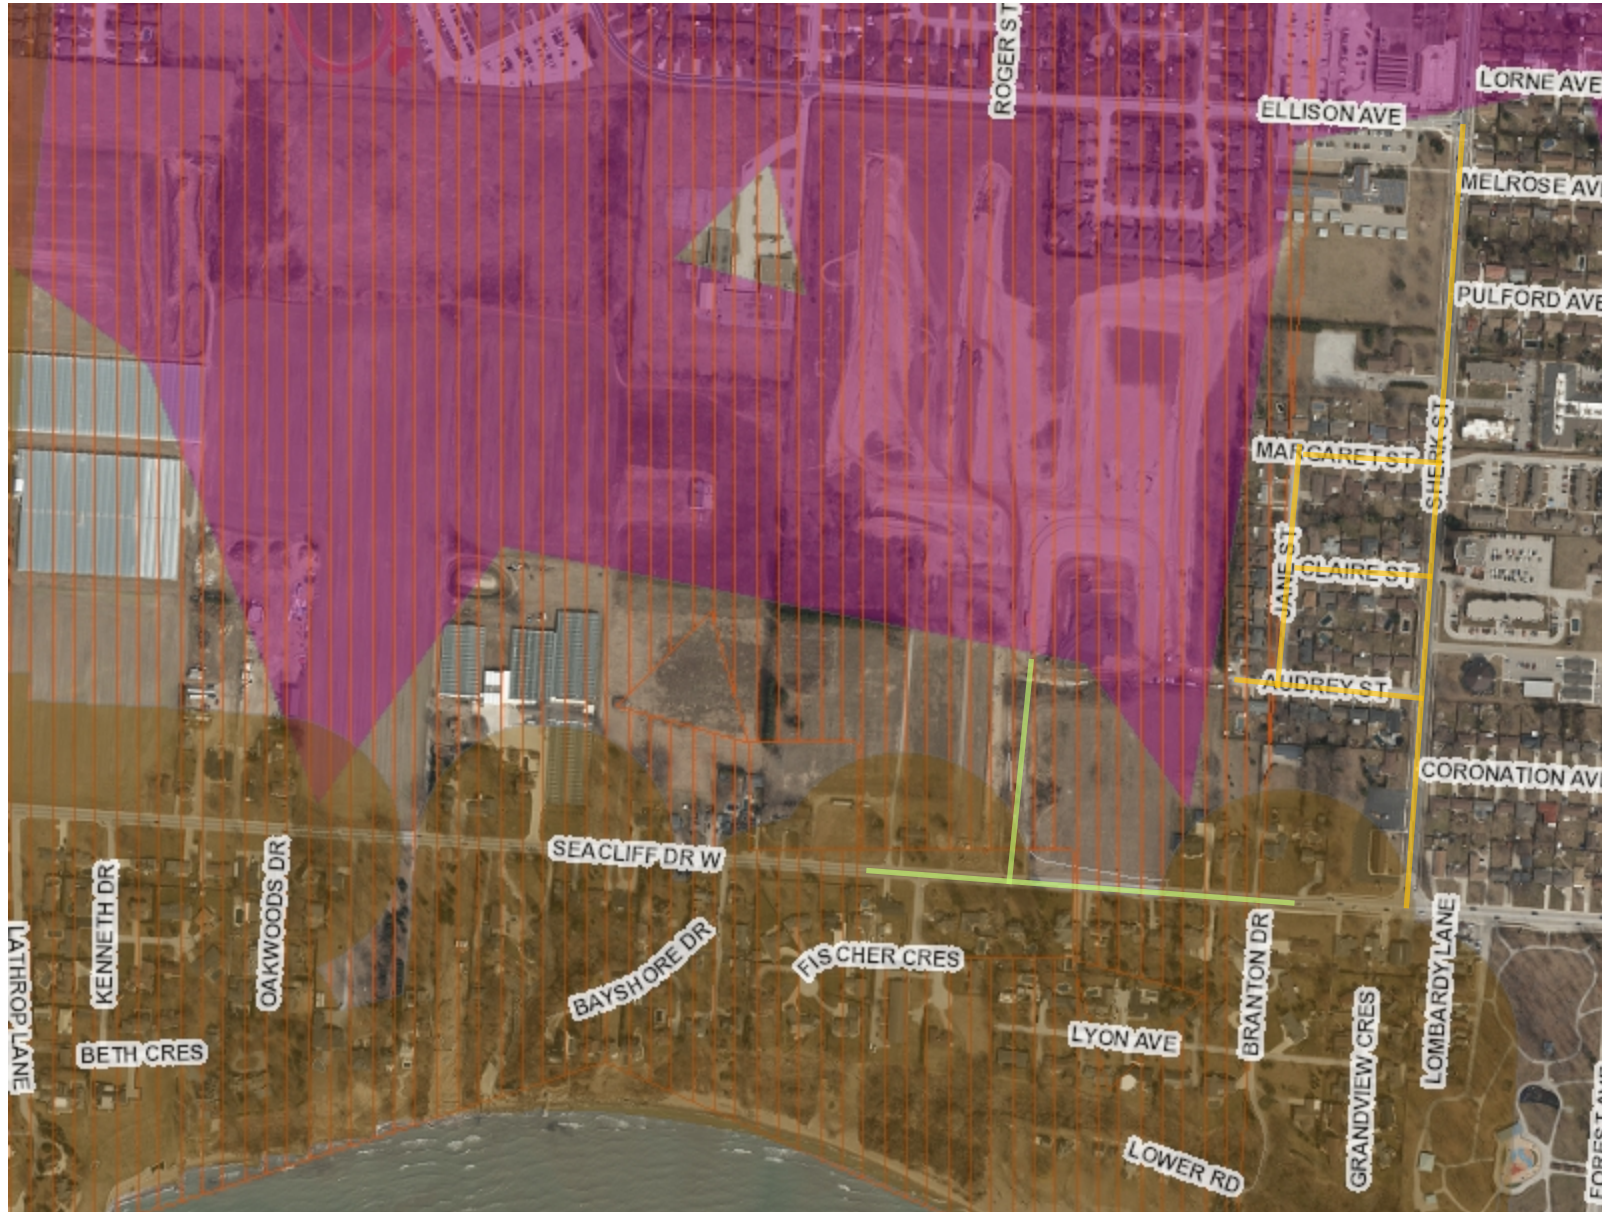
- WaterTreatmentPlant
- EventBasedArea
- HighlyVulnerableAquifer
- SignificantGroundwaterRechar
- Sewer Separation & Road Reconstruction (Margaret, Audrey, Jane, Claire & Sherk)
- Seacliff W Roundabout, Clearwater St Sewer & Road Reconstruction

Project Name	Significant Drinking Water Threat	Mitigation Measures
Seacliff West Roundabout and Clearwater Street Sewer and Road Reconstruction	No	N/A
Margaret, Audrey, Jane, Claire and Sherk Street Sewer Separation and Road Reconstruction	No	N/A
Queen, John, Albert, Baird and Elliott Street Sewer Separation and Road Reconstruction	No	N/A

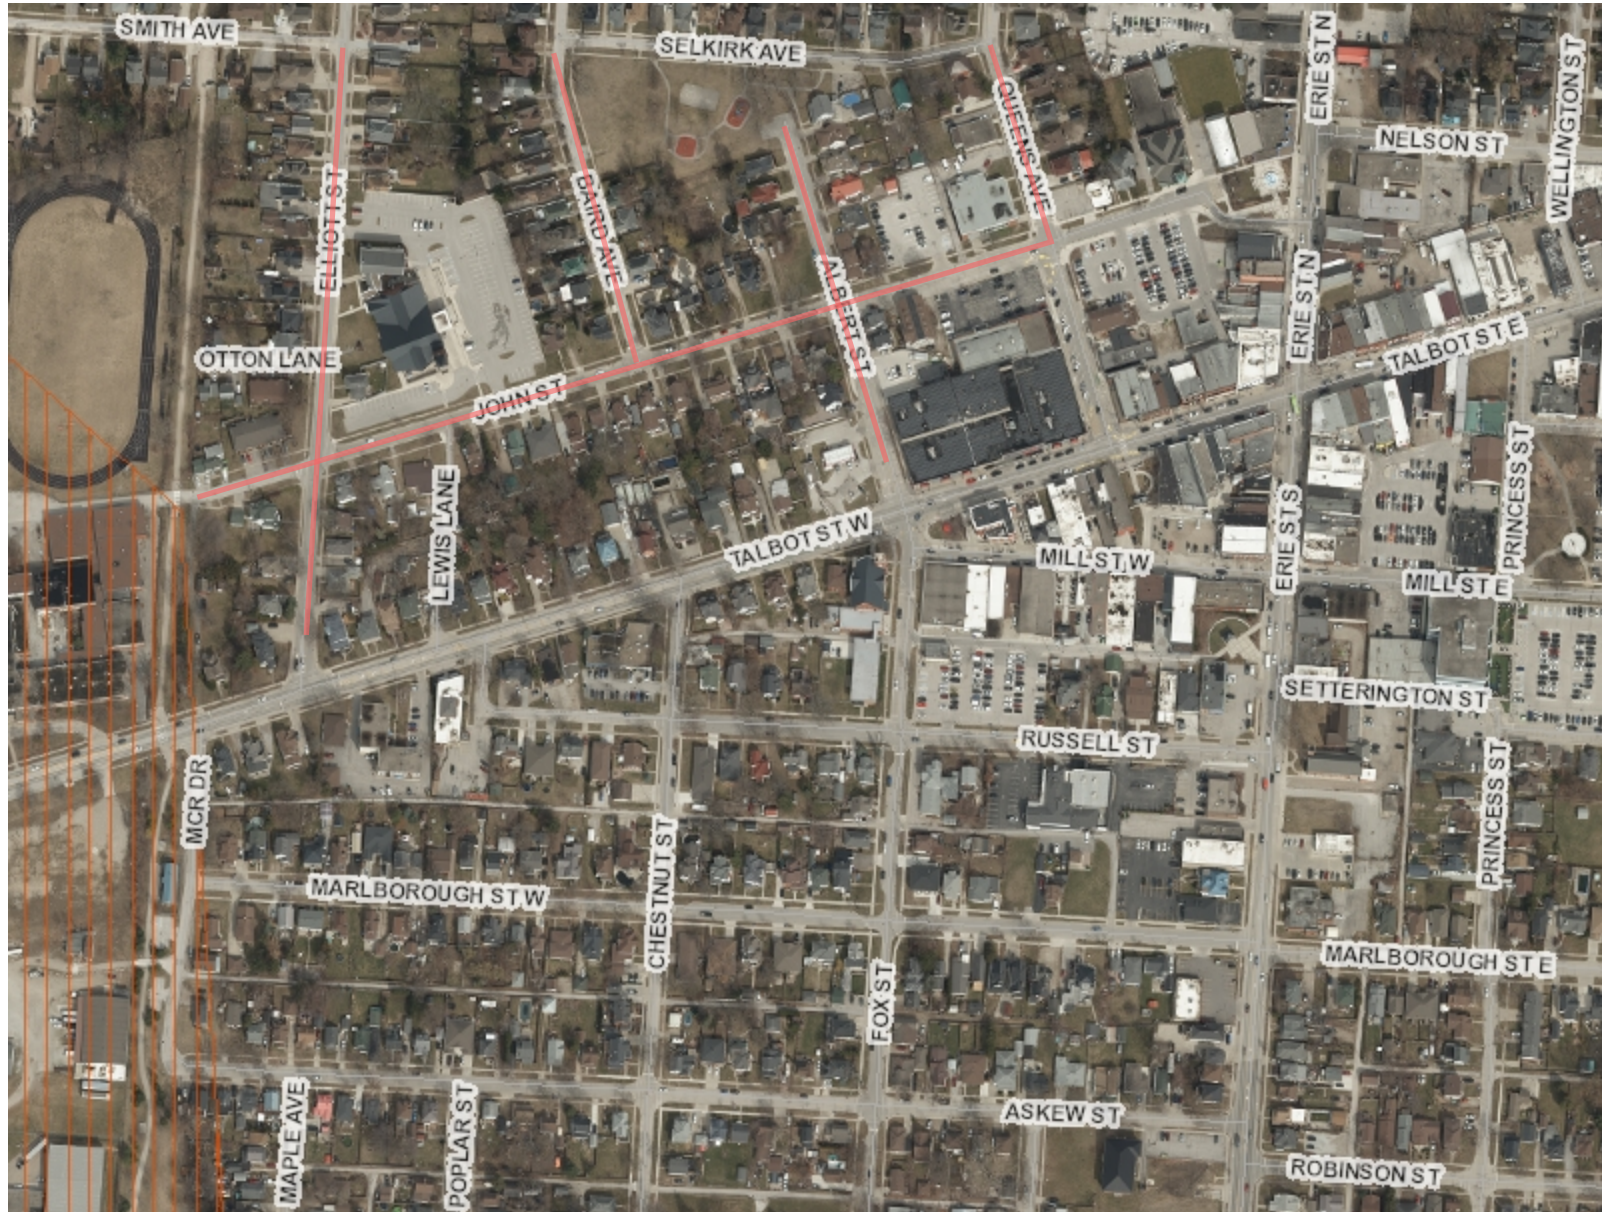
- WaterTreatmentPlant
- EventBasedArea
- HighlyVulnerableAquifer
- SignificantGroundwaterRechar
- Sewer Separation & Road Reconstruction (Queen, John, Albert, Baird & Elliot)
