Municipal Stormwater Management System 033-S701 2025 Annual Report

Submitted to:
Ontario Ministry of the Environment, Conservation and Parks
April 2026

This report was prepared to summarize The Corporation of the Municipality of Leamington Municipal Stormwater Management System operations. This report is being submitted to the Ontario Ministry of the Environment, Conservation and Parks (MECP) to satisfy the requirements of the Consolidated Linear Infrastructure Environmental Compliance Approval (CLI-ECA) 033-S701, Issue Number 2, dated July 19, 2024.

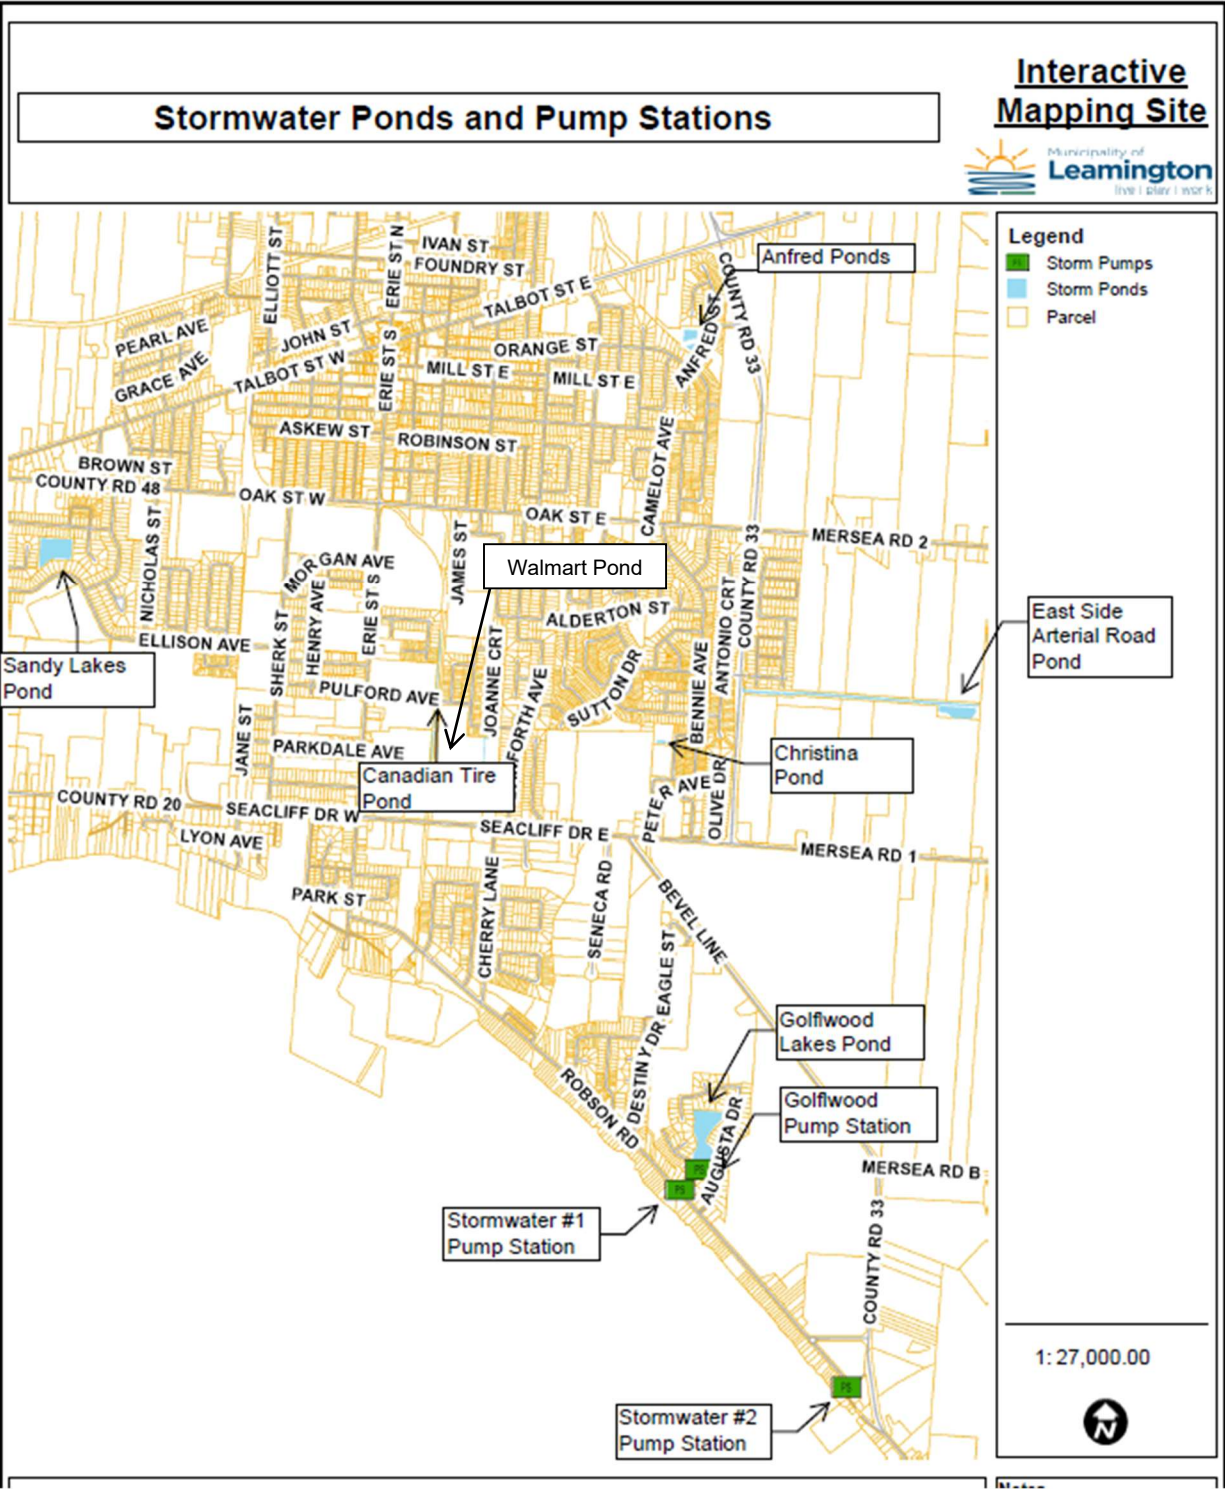
The stormwater management pond locations are shown in Figure 1.

Figure 1: Stormwater Pond and Pump Station Locations

The stormwater system includes three (3) stormwater pump stations as shown in Figure 1. All storm pump stations are equipped with one submersible pump and a local control panel that communicates to the Leamington Pollution Control Centre (LPCC) via cellular network. Pump station remote monitoring includes pump status, wet well levels and alarms. No sampling was completed for the storm pump stations in 2025.

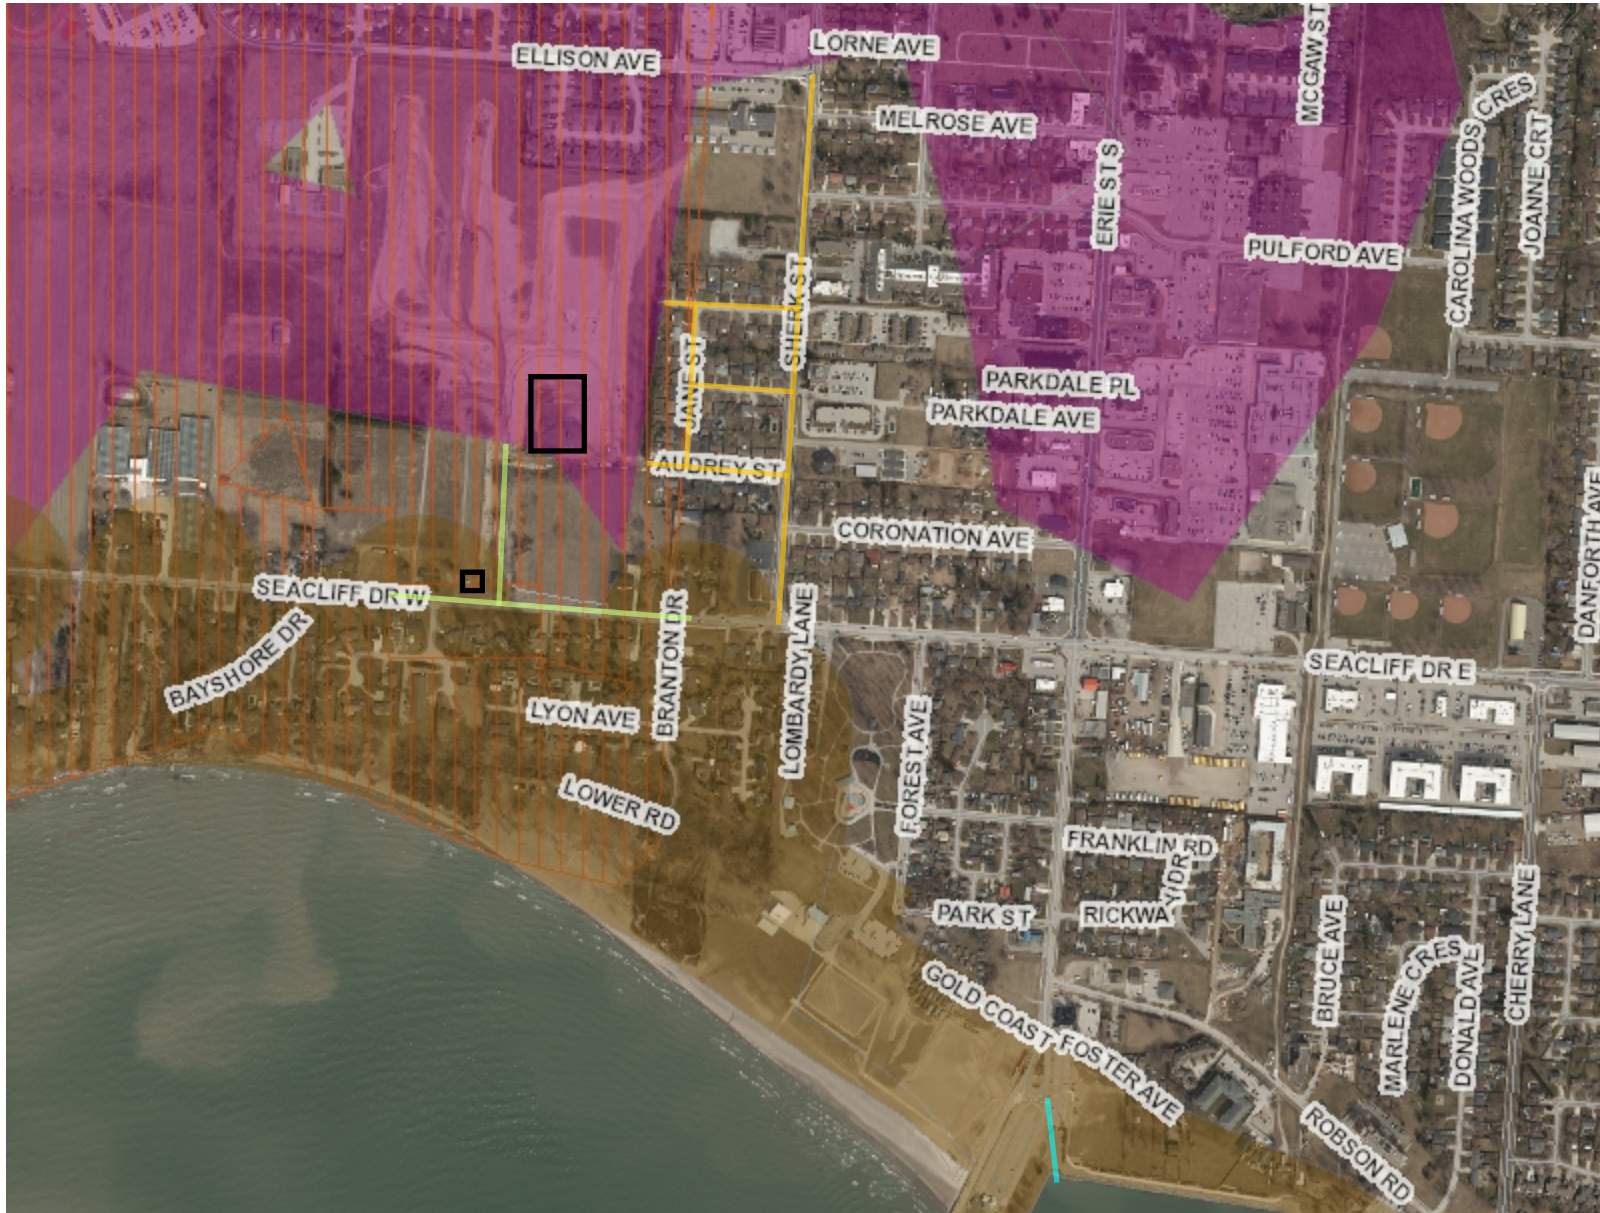
- Water Treatment Plant
- Event Based Area
- Highly Vulnerable Aquifer
- Significant Groundwater Recharge
- SW Storm Pond & Pump Station
- Erie Outfall Relocation
- Seac Cliff W Roundabout, Clearwater St Sewer & Road Reconstruction
- Sewer Separation & Road Reconstruction (Margaret, Audrey, Jane, Claire, Sherk)

Project Name	Significant Drinking Water Threat	Mitigation Measures
Seacliff West Roundabout and Clearwater Street Sewer and Road Reconstruction	No	N/A
Southwest Stormwater Pond and Pumping Station	No	N/A
Margaret, Audrey, Jane, Claire and Sherk Street Sewer Separation and Road Reconstruction	No	N/A
Queen, John, Albert, Baird and Elliott Street Sewer Separation and Road Reconstruction	No	N/A
Erie Street South Outfall Relocation	No	N/A

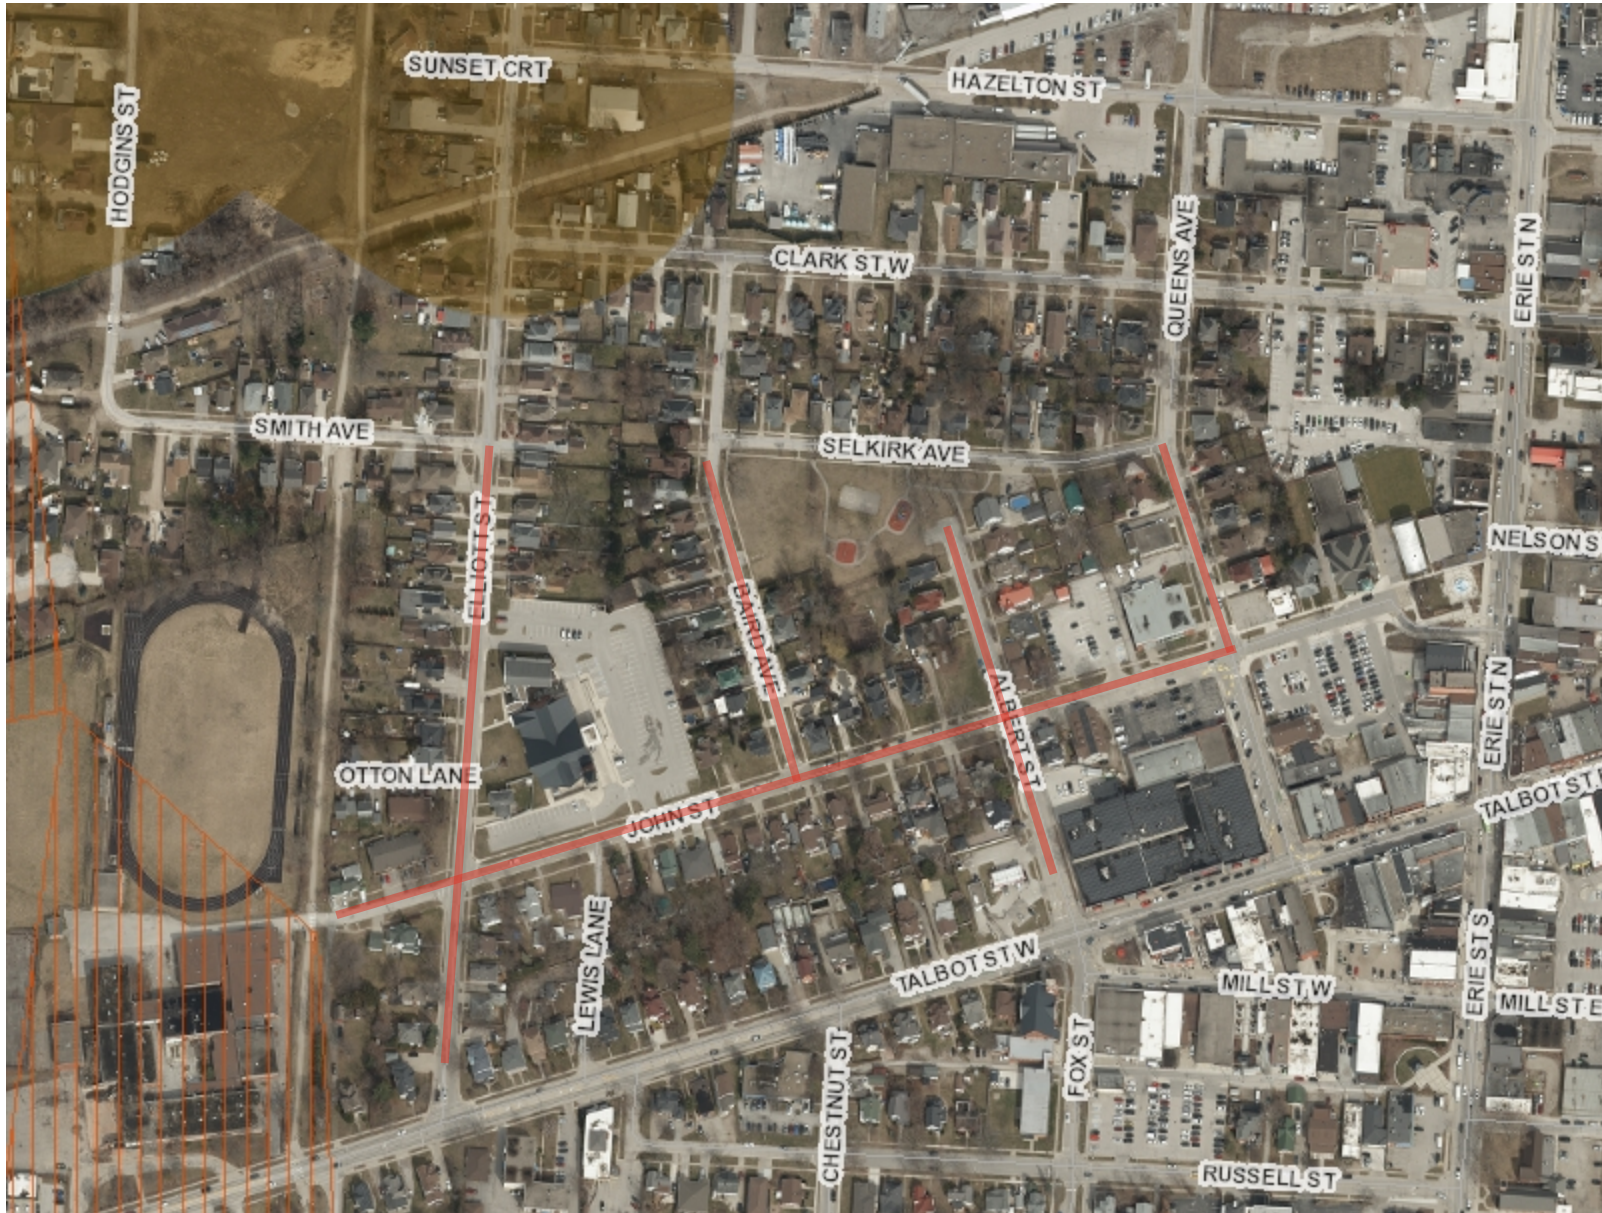
- SurfaceWaterIntake
- EventBasedArea
- ▨ HighlyVulnerableAquifer
- SignificantGroundwaterRechar
- Sewer Separation & Road Reconstruction (Queen, John, Albert, Baird & Elliot)
